# BRE Test Report

## Rain Penetration Tests on Manthorpe Small Format Slate Vent

Prepared for: Ben Hales  
Date: 14<sup>th</sup> February 2017  
Report Number: P107103-1000: Issue 2

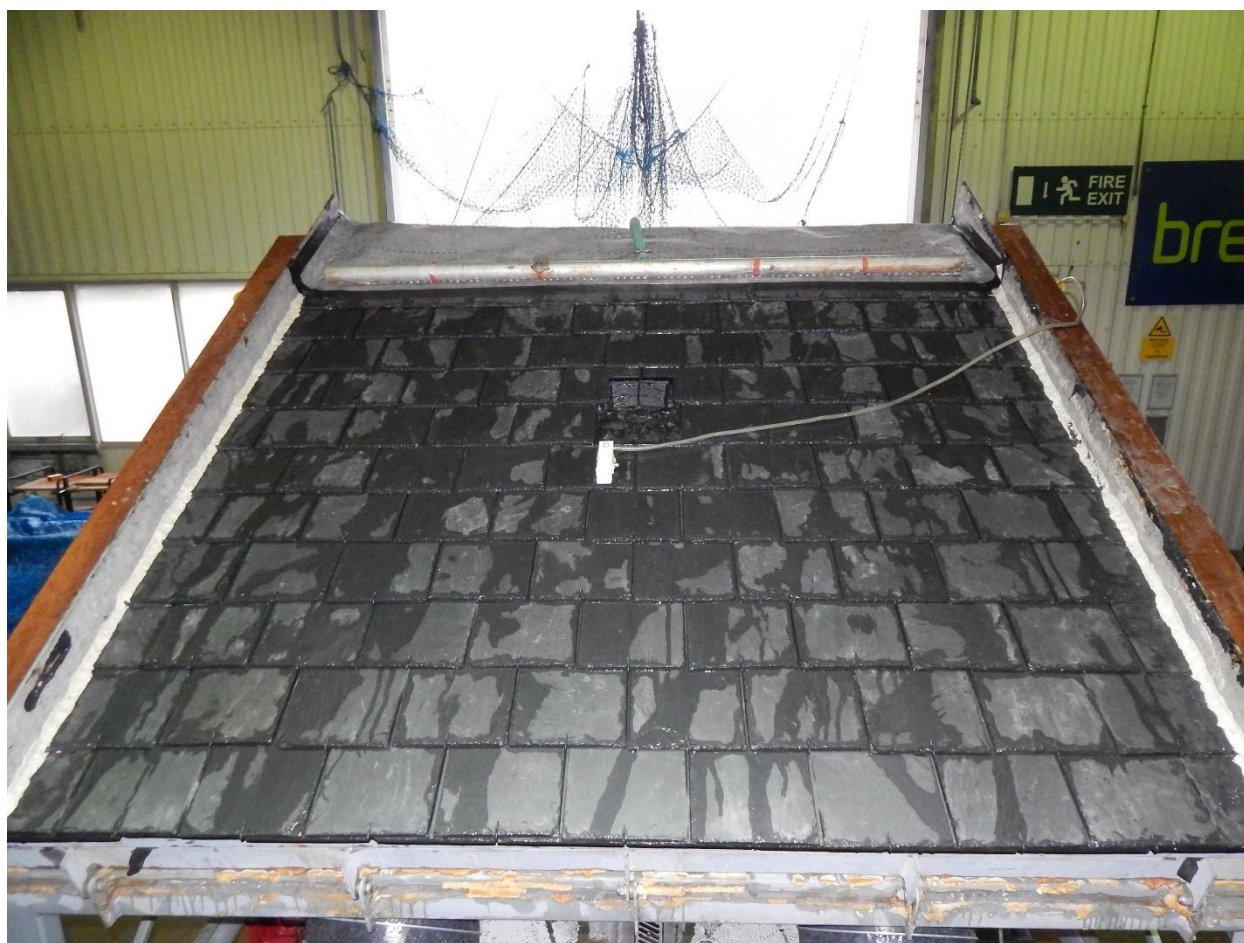
Figure 1 Small Format Slate Vent Tile installed with Natural Slate tiles

The vent and tiles were installed on the BRE test rig by Manthorpe employees. For these tests Natural Slate and Fibre Cement tiles were used on separate rigs. Figure 1 shows the vent installed on the Natural Slate rig. Figure 2 shows the vent installed on the Fibre Cement rig.

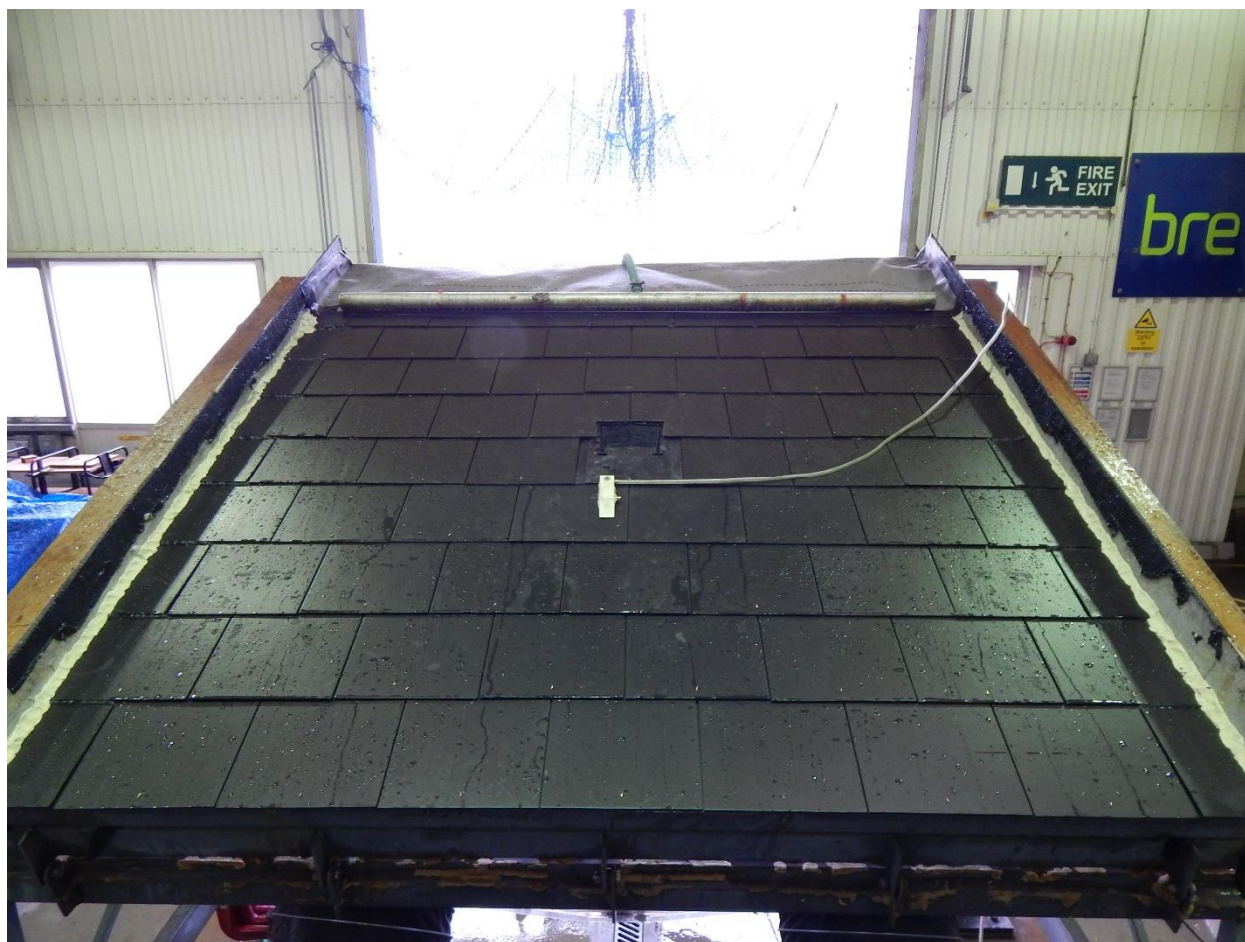
Figure 2 Small Format Slate Vent installed with Fibre Cement Tiles

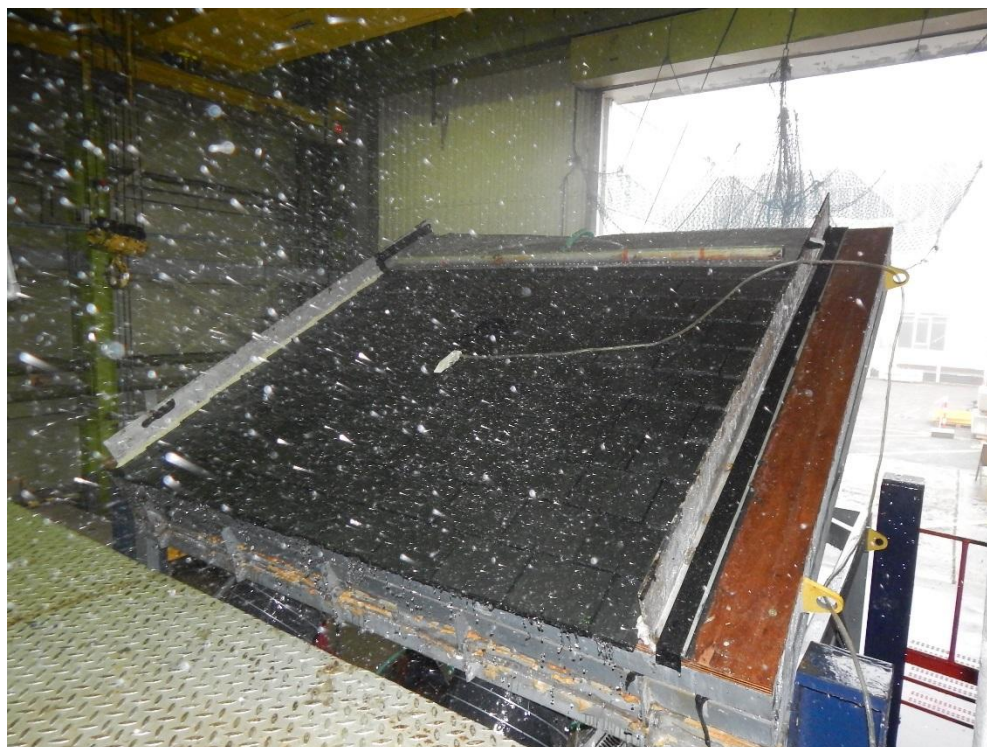
Figure 3 Manthorpe Small Format Vent Tile with Natural Slate tiles under test

The performance of the roof vent was investigated using a purpose-built monopitch test roof of nominal size 2m x 2m. On the underside of the test roof, and central to it, a 1.8m wide x 1.6m long shallow Perspex box (open area 2.88m<sup>2</sup>) was mounted. It was this box that allowed the pressure underneath the tiles to be controlled. This test rig fully complies with the requirements laid down in FprEN 15601:2006 and has been calibrated to give the required uniformity of wind speed and rain flow across the test specimens. Results of the calibration tests on the BRE test rig and details of the turbulence intensity in the flow are presented in Annex B. Figure 3 & 4 show the roof vent and tiles under test.

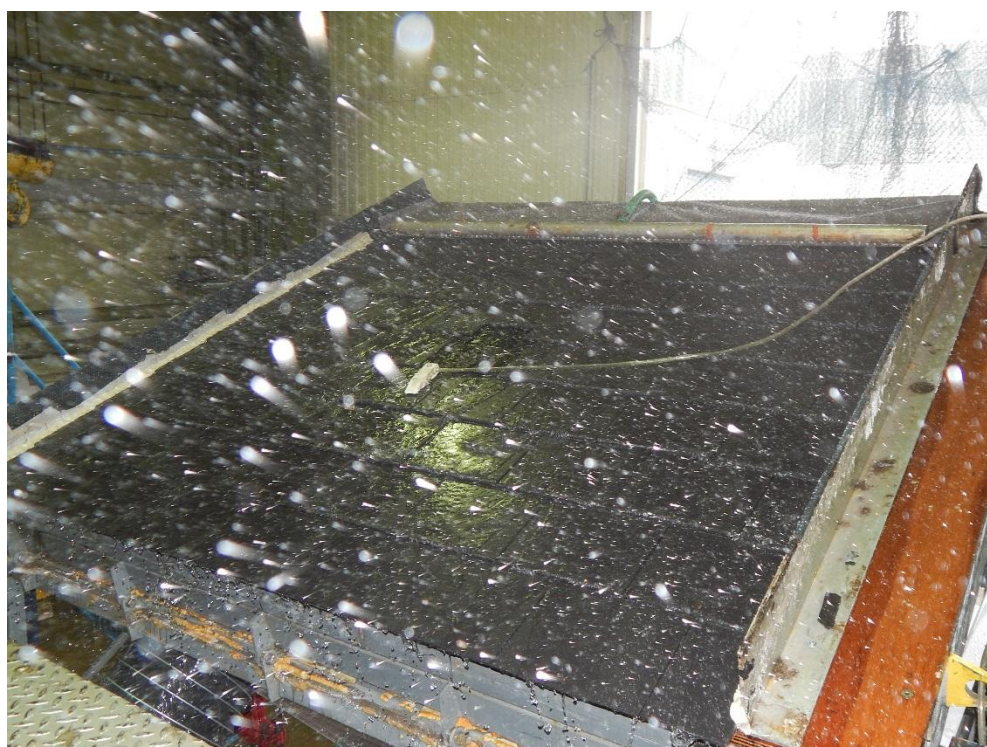
Figure 4 Manthorpe Small Format Vent Tile with Fibre Cement tiles under test

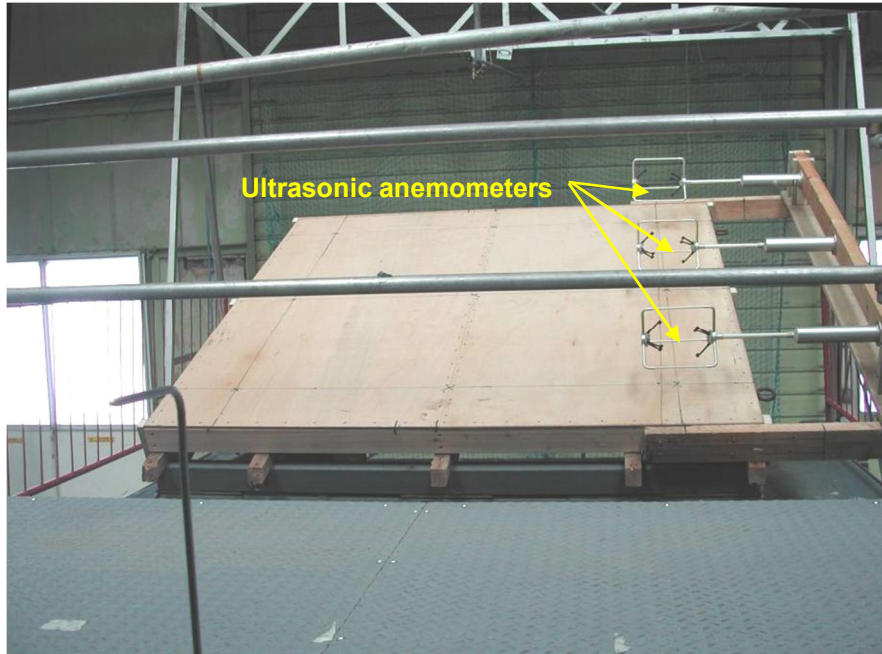
Figure B2 Calibration of the wind speed over the test specimen area

Table B1 shows the calibration measurements. The maximum turbulence intensity across the specimen is 5.57% and occurs at location 5 in the centre of the specimen. In all cases the turbulence intensity is within the limit of 10% allowed by the draft standard.

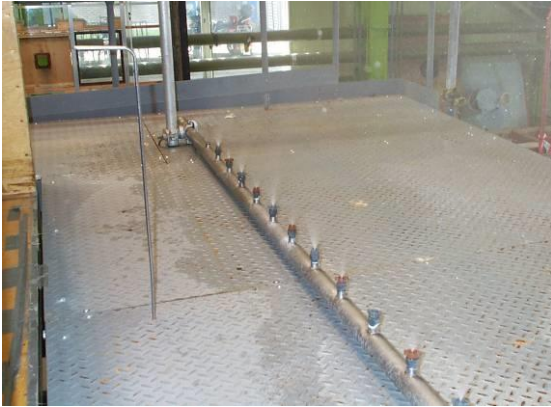
Figure B3 Bottom spray bar

Figures B3 to B6 show the calibration of the driving rain in the BRE test rig. The results of the calibrations for Sub-Tests A, B and C for the Northern European Coastal climate are shown in Table B2. From Table B2 it can be seen that the degree of variability in Sub-Tests A, B and C is close to but just within the allowable limit of  $\pm 35\%$ .

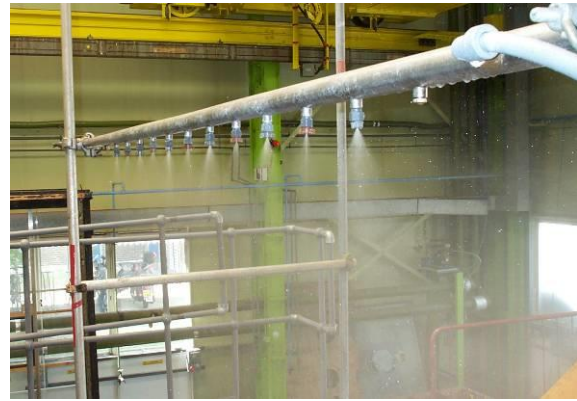
Figure B4 Top spray bar

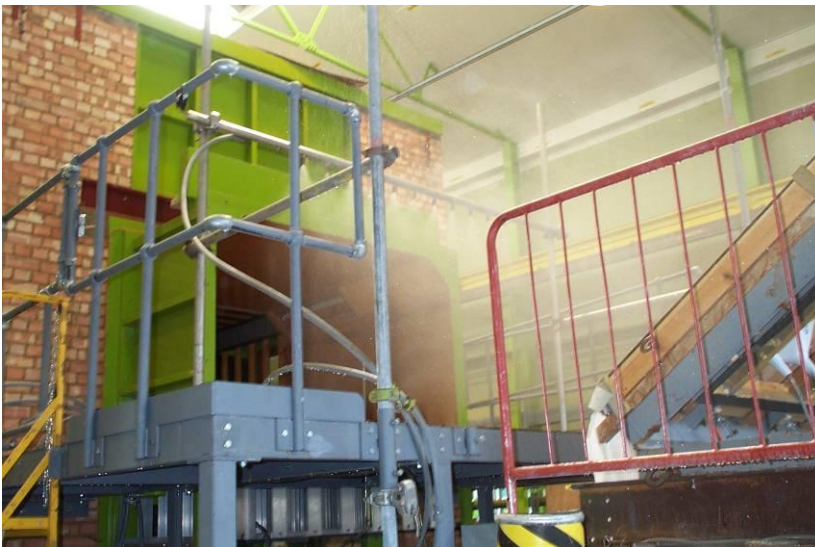
Figure B5 View of the test rig at the end of the tunnel

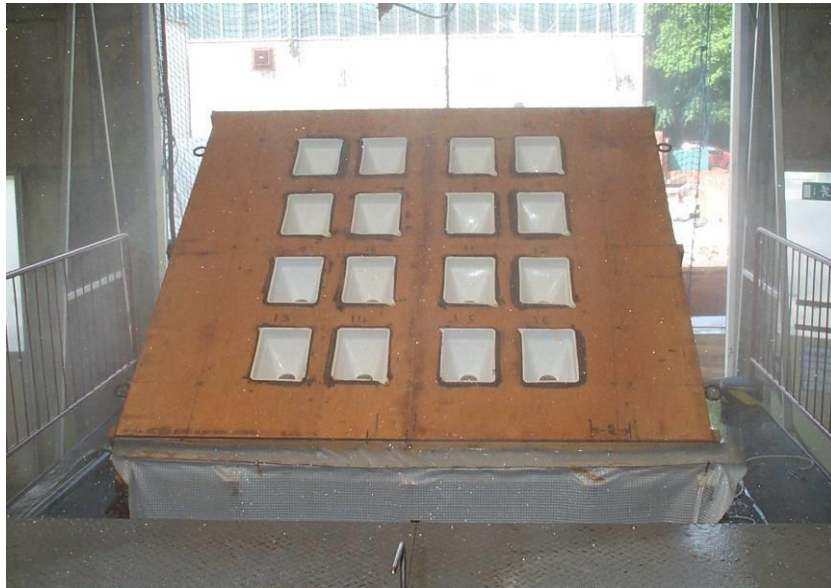
Figure B6 View of the 16 rainfall collection buckets on the test rig
