BRE Test Report

High Speed wind tests on the Manthorpe SmartVerge Interlocking Plain Tile Verge System

Prepared for: Ben Hales
Date: 15th August 2022
Report Number: P123548-1000

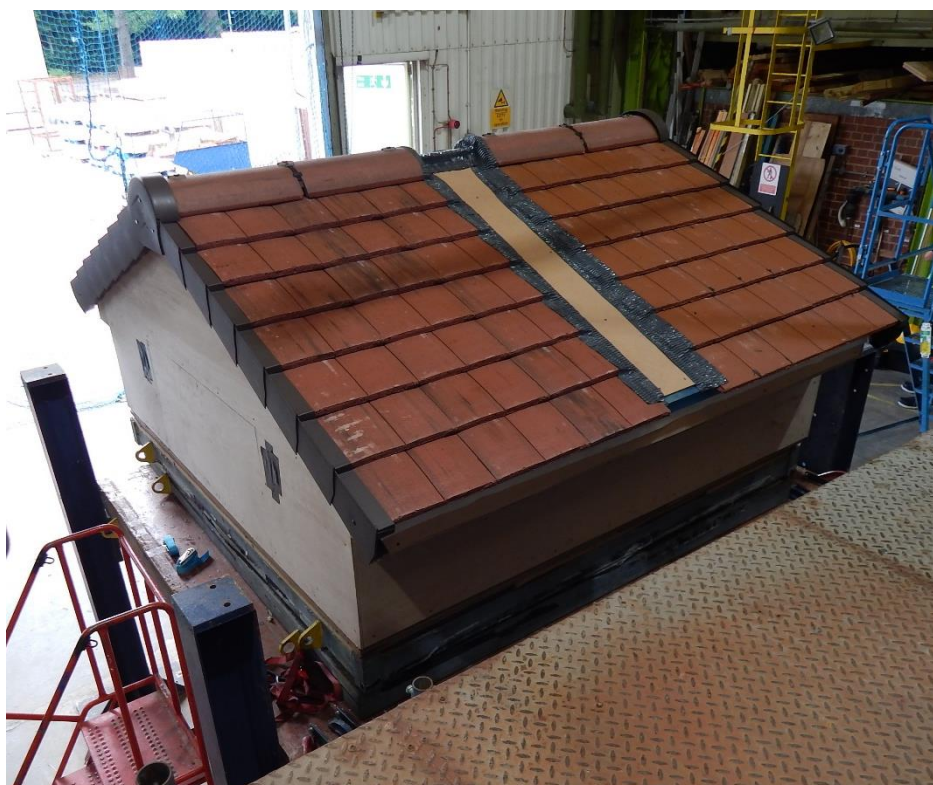
Figure 1. Manthorpe SmartVerge Interlocking Plain Tile Verge system installed with interlocking plain tiles.

Figure 1 shows the test rig prior to test. Additional photos are included in Appendix A.

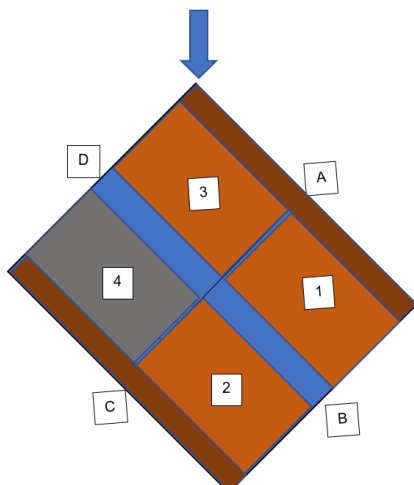
4.4 Test 4 – Junction of Face A and Face D

Tunnel Speed (m/s)	Time (mins)	Details
25	2	No Movement
30	2	No Movement
35	2	No Movement
40	2	No Movement
48	2	5 th course of tiles in section 3 pushing up on verge unit & chattering Top course of tiles in section 1 pushing up on verge unit & chattering
48.75	5	As above

No visible damage occurred during the test.

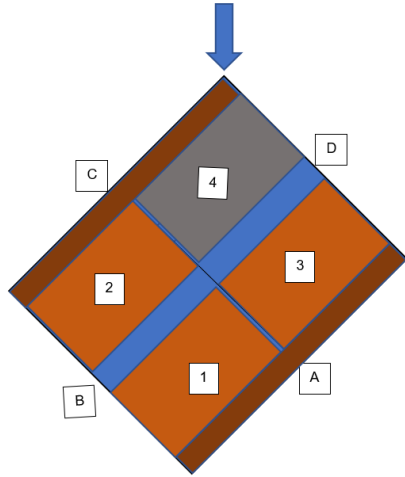
4.5 Test 5 – Junction of Face D and Face C

Tunnel Speed (m/s)	Time (mins)	Details
25	2	No Movement
30	2	No Movement
35	2	No Movement
40	2	No Movement
48	2	No Movement
48.75	5	No Movement

No visible damage occurred during the test.

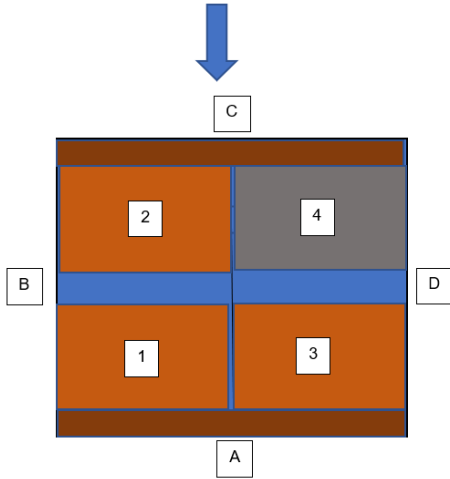
4.7 Test 7 - Face C

Tunnel Speed (m/s)	Time (mins)	Details
25	2	No Movement
30	2	No Movement
35	2	No Movement
40	2	No Movement
48	2	3 rd , 4 th , 5 th course of tiles in section 2 pushing up on verge unit & chattering Middle of 2 nd , 3 rd , 4 th course of tiles in section 2 chattering 2 nd , 3 rd , 4 th , 5 th , 6 th course of tiles in section 4 chattering
48.75	5	As above

No visible damage occurred during the test.

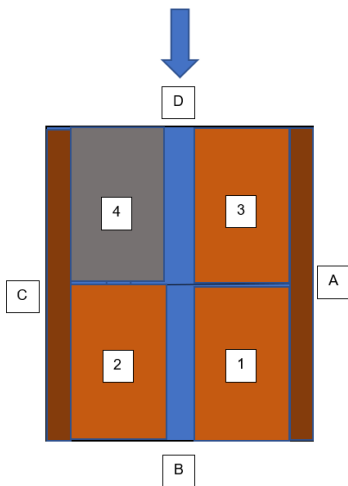
4.8 Test 8 – Face D

Tunnel Speed (m/s)	Time (mins)	Details
25	2	No Movement
30	2	No Movement
35	2	No Movement
40	2	No Movement
48	2	Tiles in middle and end courses being held down by verge units chattering 3 rd course of tiles in section 3 under verge chattering
48.75	5	As above

No visible damage occurred during the test.

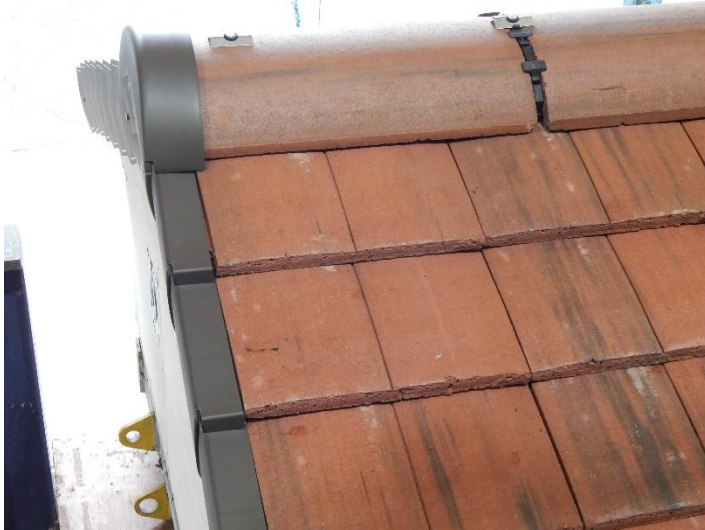
Close up of Manthorpe SmartVerge Interlocking Plain Tile Verge system and SmartVerge Interlocking Plain Tile Eaves Closure.
