# Manthorpe dry fix systems - testing to BS8612:2018 and high-speed wind tunnel testing

Prepared for: Manthorpe Building Products

Report number: P127035-1001

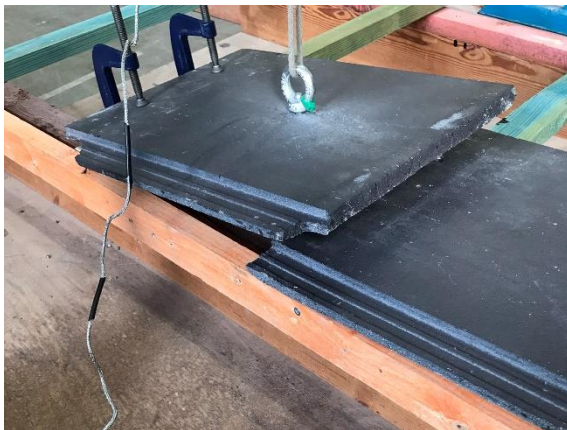
**Figure 2:** Type A with sidelock notched.

Annex F testing was conducted with standard tiles (Type A) and with modified tiles (Type B) where the sidelocks were removed under client instruction. For both types a notch was also added to allow the tile to freely rotate on the test rig.

- Type A: Sidelock notched.
- Type B: Sidelocks removed and the tiles notched.

These modifications can be seen in Figures 2 and 3.

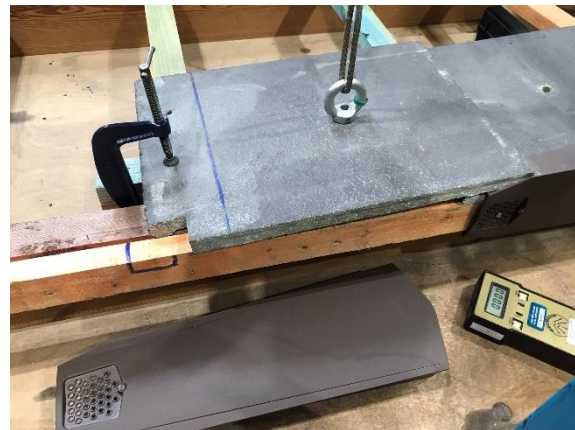
**Figure 3:** Type B with sidelock removed and tile notched.

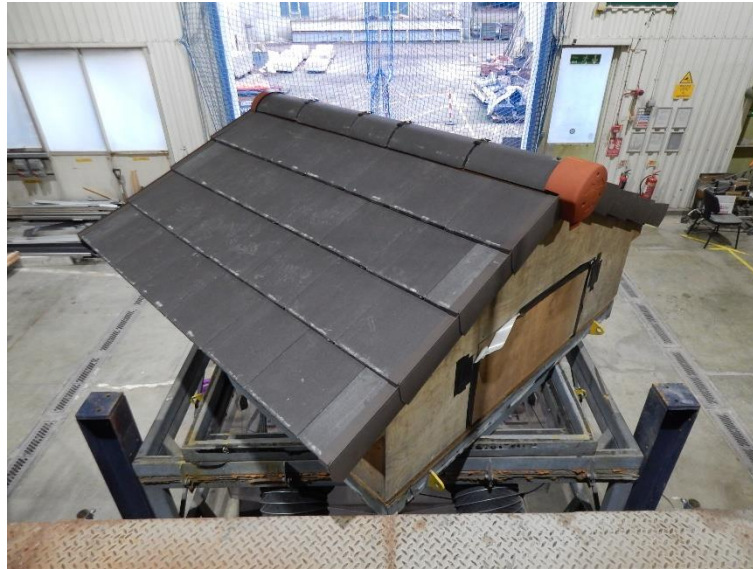
**Figure 4:** Products installed on BRE test rig.

The specimen for the high-speed wind tunnel testing was built using the following products on the BRE test rig. The test rig is 2 x 2 m box with a 22.5° duo-pitch roof, see Figure 4.

- Marley Edgemere concrete tiles.
- MBP\_GU\_GPPV-TLE Dry Fix Verge System.
- GDRR-ULTRA Roll-out Ridge System.
- GPPV-END-R Round Ridge End Cap.
- GBAT Ridge Roost bat conservation roost.

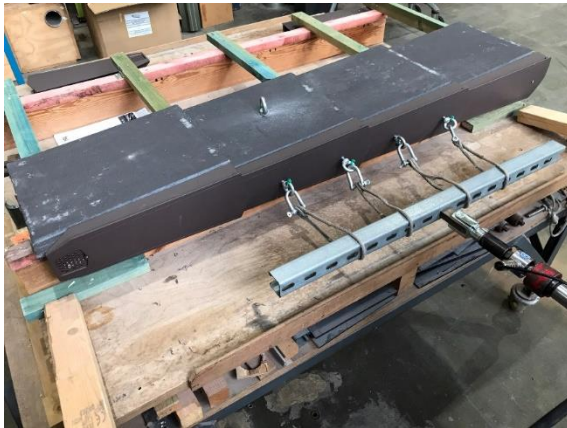
**Figure 5:** Before test.

The results from the load tests on the verge unit are given in Table 7. They are given per verge unit. The results were within 15% of the mean so no further testing was required. Photos from before and after the test are shown in Figures 5 and 6.

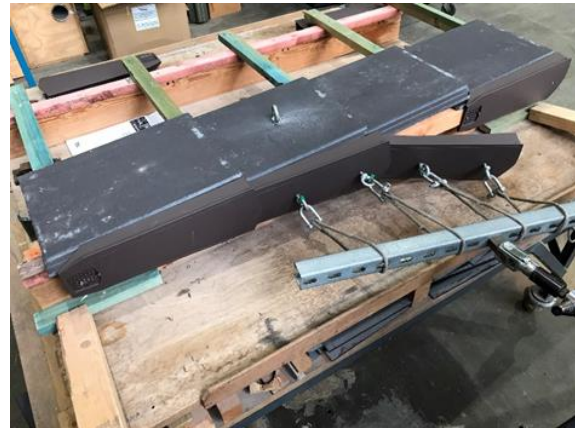
**Figure 6:** After test showing failure mode.

All tests ended when criteria d) was met, this is a serviceability criteria. It was not possible to continue the test to an ultimate failure mode as the verge units did not re-engage when the load was removed.

Test Number	$F_{v,s}$ (N)	Failure mode
Test 1	307	Right verge unit unclipped from right verge unit
Test 2	294	Right verge unit unclipped from right verge unit
Test 3	339	Left verge unit unclipped from right verge unit

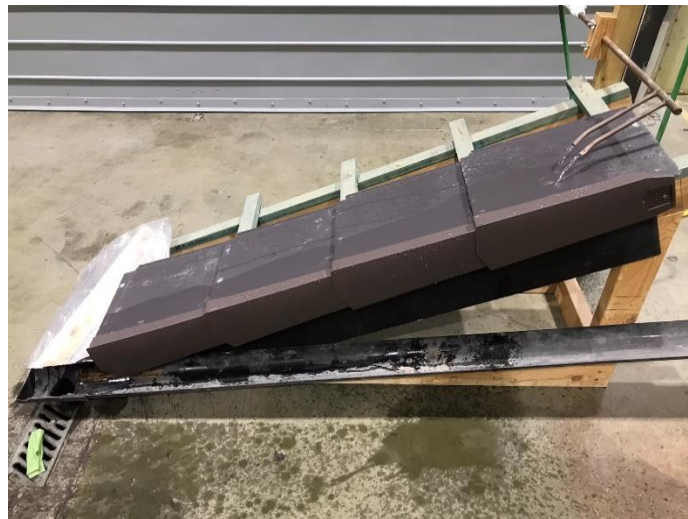
**Figure 9:** Manthorpe dry verge under the rain drainage test.

In the rain drainage tests none of the verge units allowed water to discharge in concentrated continuous or intermittent streams on to the fascia board in any of the 3 tests. Figure 9 shows the verges under test.

The Manthorpe MBP\_GU\_GPPV-TLE dry verge unit meets the rain drainage performance requirements of Annex G.
