**Testing of SmartDrain
and SlotDrain Linear
Drainage Units**

Prepared for: Mike Challinor
Manthorpe Building Products
Ltd, Manthorpe House, Brittain
Drive, Codnor Gate Business
Park, Ripley, Derbyshire
DE5 3ND

Test report number 289 099

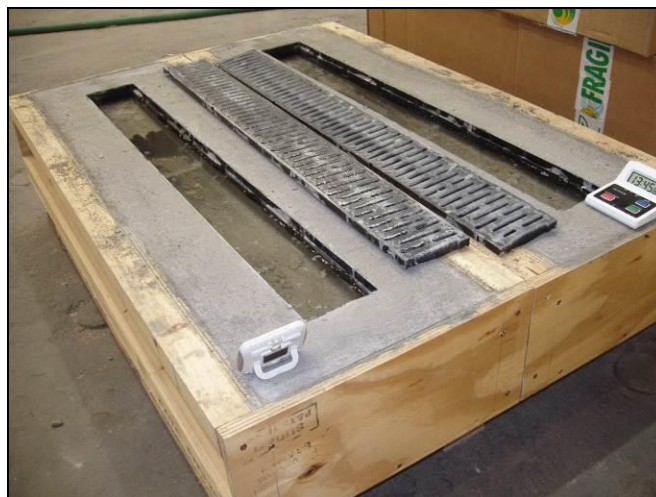
Figure 3: Photograph showing 2 of the 3 assemblies for watertightness test of channel body

Three samples of the SmartDrain units were tested in accordance with clause 7.5.1. Each sample consisted of a 1m total length of SmartDrain channel body, supplied by Manthorpe Building Products Limited as being bonded together approximately half way along the length of the channel body according to the manufacturer's instructions, and haunched in a concrete casing of approximately 1200 x 320 x 190 mm. See Figure 3 below. The ends of the channel body were sealed by means of an end plate. The units were filled with water to the maximum designed wetted perimeter as indicated by the manufacturer's representative, and the units were inspected for any signs of leakage through the channel body and the joint, for a period of 30 minutes.

It should be noted that the SmartDrain and SlotDrain units comprise the same channel body and jointing method, therefore only one type of unit (in this case SmartDrain) was considered necessary to demonstrate the performance of the jointing method.

⁽¹⁾Following completion of the 30 minutes test period the units were re-inspected approximately 3 hours after the initial application of water into the test samples. There was no visible leakage through the joint or body.

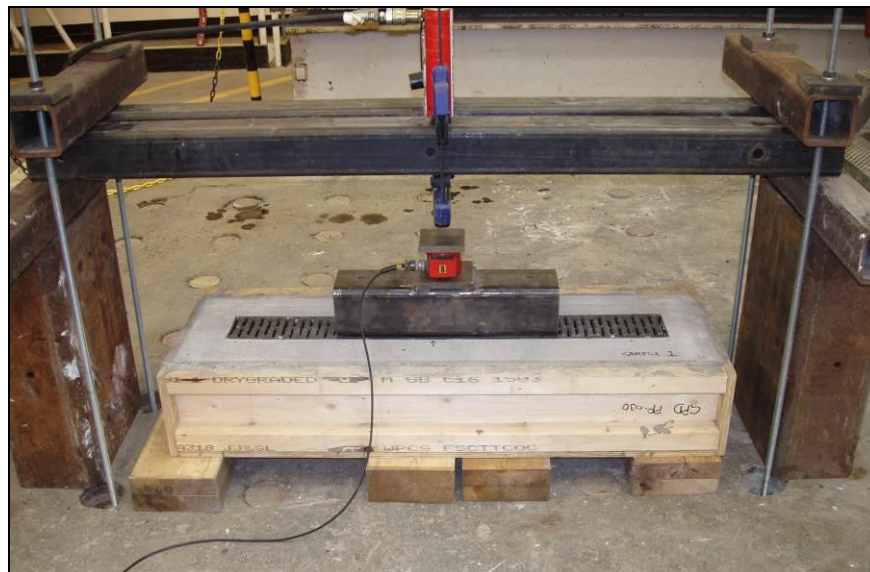
Figure 4: Photograph showing assembly for load test of SmartDrain unit

The units were placed into a compressive test rig as shown in Figures 4 and 5 of this Report.

For the maximum load testing the load was applied to achieve a target of 15kN. Upon reaching 15kN the load was maintained for a period of 30 seconds.

⁽²⁾The unit was subsequently loaded to 60kN without cracking or excessive deformation

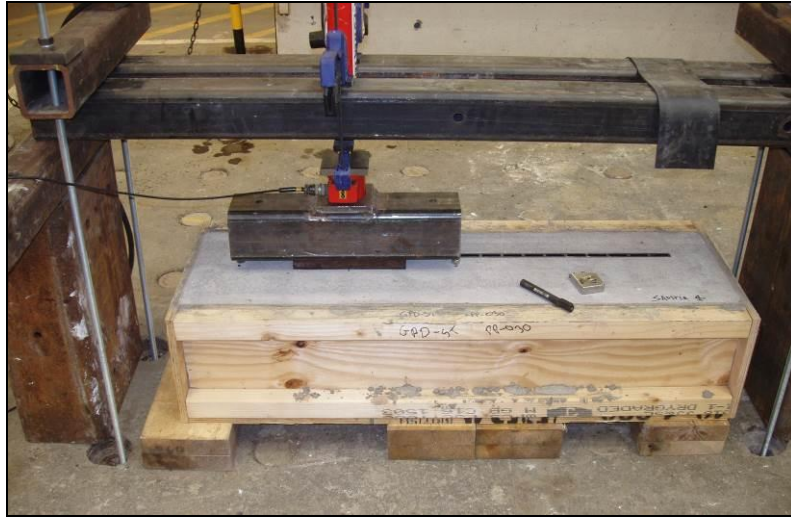
Figure 5: Photograph showing assembly for permanent set test of SlotDrain unit

For the permanent set testing an initial datum point was established at the centre of the grating using a calibrated dial test indicator. After 5 applications of the permanent set load of 10kN a final reading of deflection of the grating was recorded and the permanent set of the grating was calculated as the difference between the initial and final readings.

Sample No	Specified maximum permanent set (mm)	Actual permanent set (mm)	Assessment
1	0.40 max	0.04	Pass
2		Nil	Pass
3		Nil	Pass

⁽³⁾The unit was subsequently proof loaded. At approximately 25kN a hairline concrete crack appeared on the surface of the unit adjacent to the slots, however the unit was further loaded to 60kN without any further cracking of the concrete or excessive deformation.
