**Driving Rain Testing on
Redland 50 double roman
roof tiles and the
Manthorpe large format
concrete interlocking tile
vent**

Prepared for: Mr Ben Hales,
Product designer

25th November 2010

Report number 267473

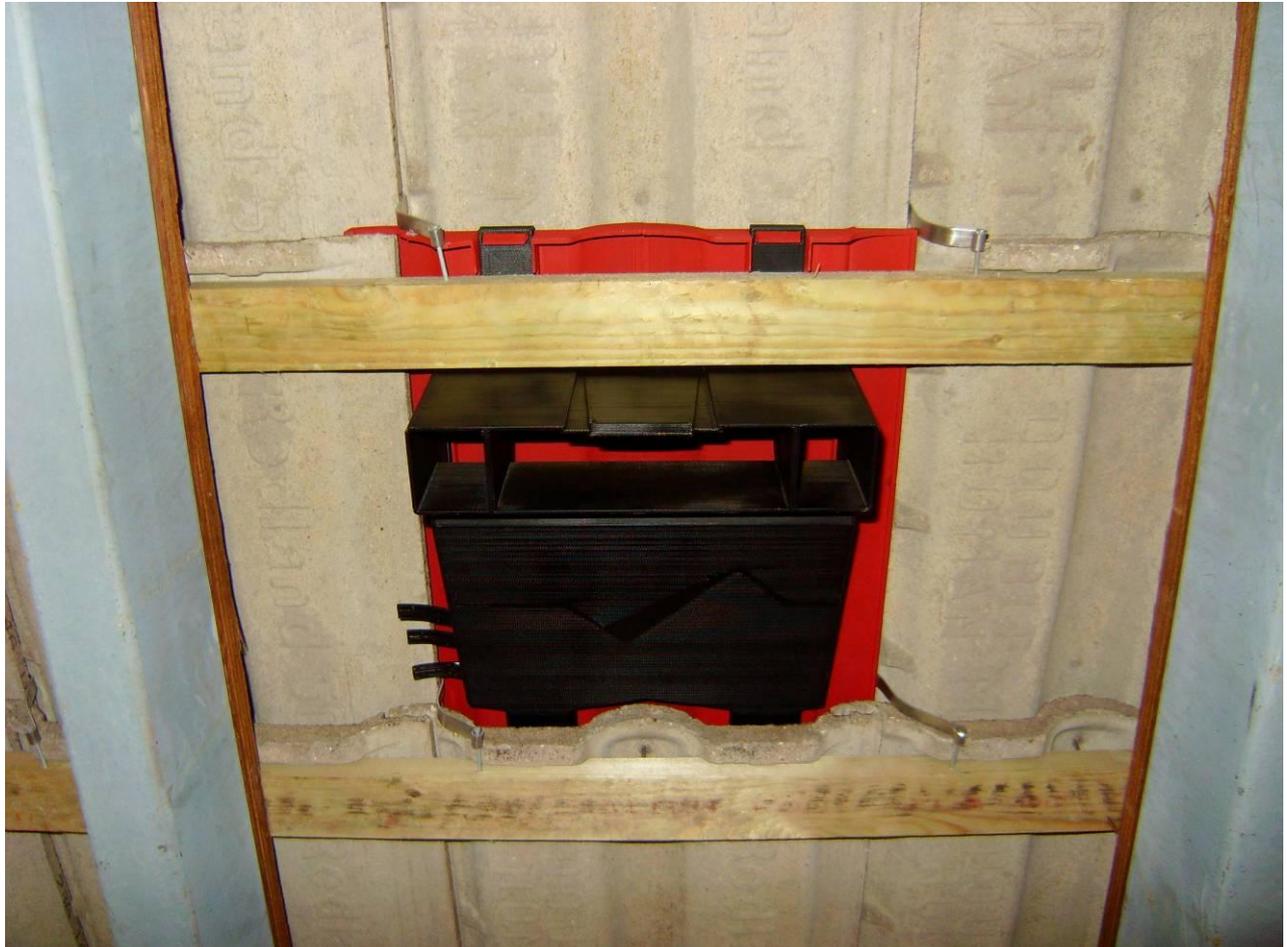
Figure 2 An underside view of the Manthorpe large format concrete interlocking tile vent installed in the test roof

Figure 1 and 2 shows details of the installed Vent and how it interfaces with the roof tiles, from above and below. Figure 3 shows an overall view of the Vent and Tiles on the BRE test rig.

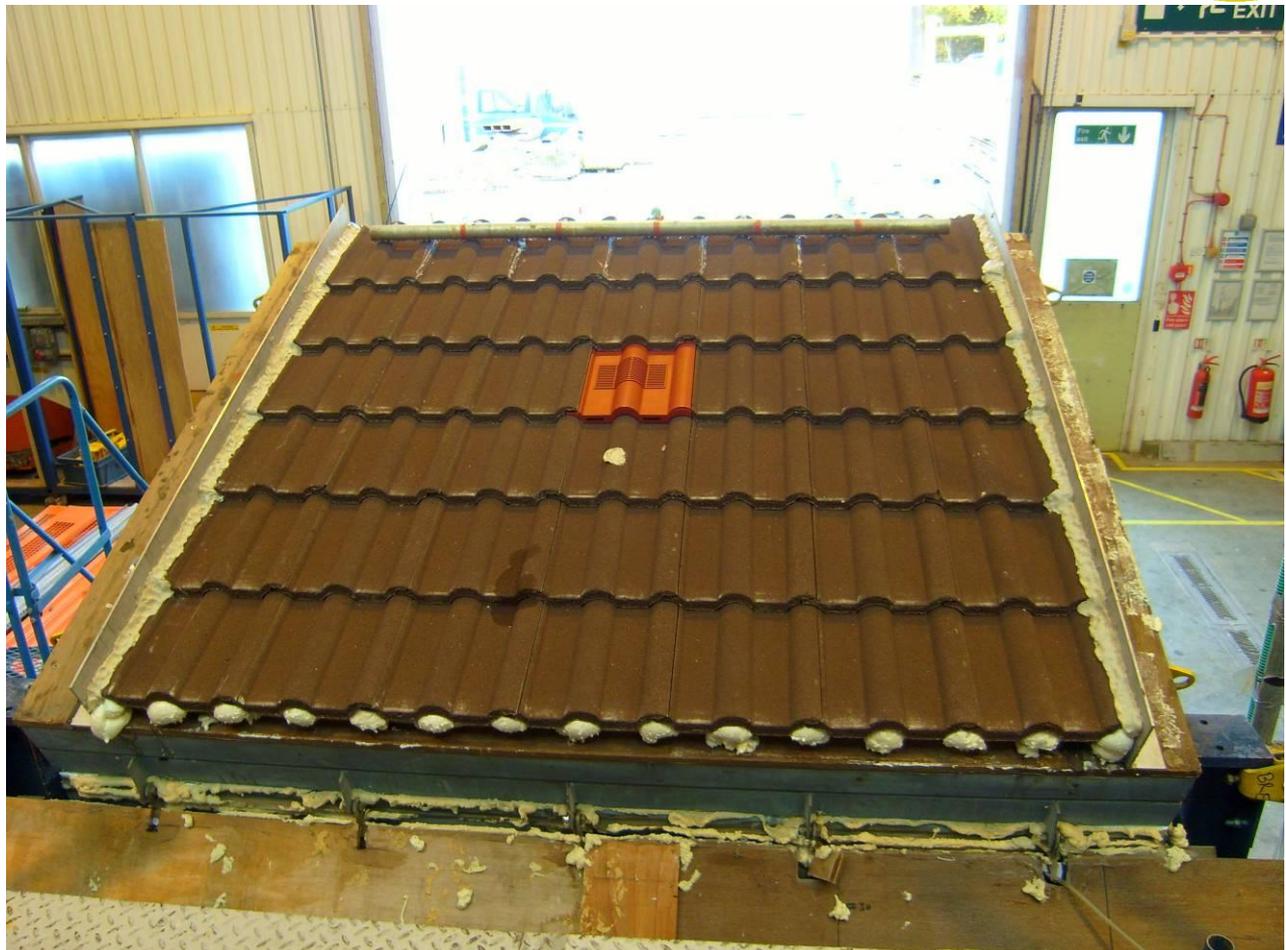
Figure 3 An general view of the roof tiles and the Manthorpe large format concrete interlocking tile vent installed in the test roof.

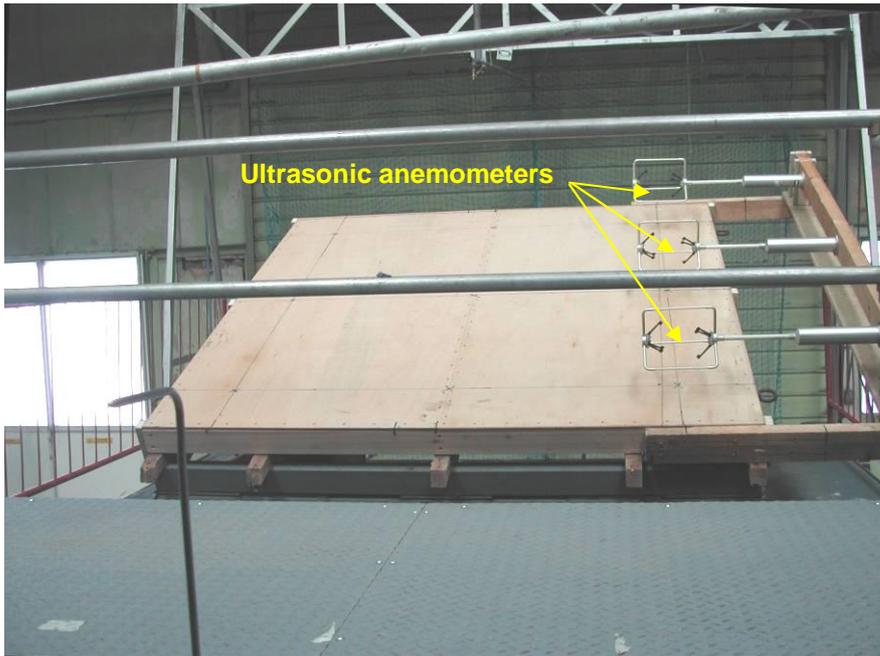
Figure C2 Calibration of the wind speed over the test specimen area

Table C1 shows the calibration measurements. The maximum turbulence intensity across the specimen is 5.57% and occurs at location 5 in the centre of the specimen. In all cases the turbulence intensity is within the limit of 10% allowed by the draft standard.

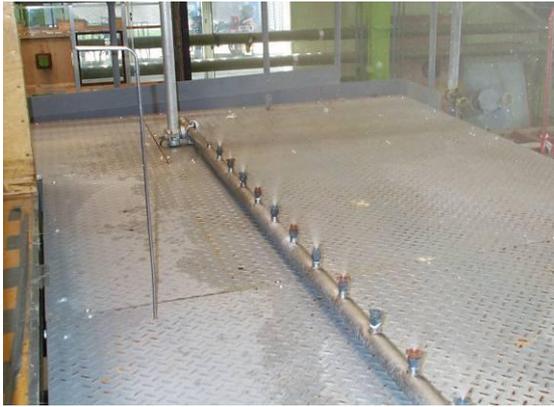
Figure C3 Bottom spray bar

Figures C3 to C6 show the calibration of the driving rain in the BRE test rig. The results of the calibrations for Sub-Tests A, B and C for the Northern European Coastal climate are shown in Table C2. From Table C2 it can be seen that the degree of variability in Sub-Tests A, B and C is close to but just within the allowable limit of $\pm 35\%$.

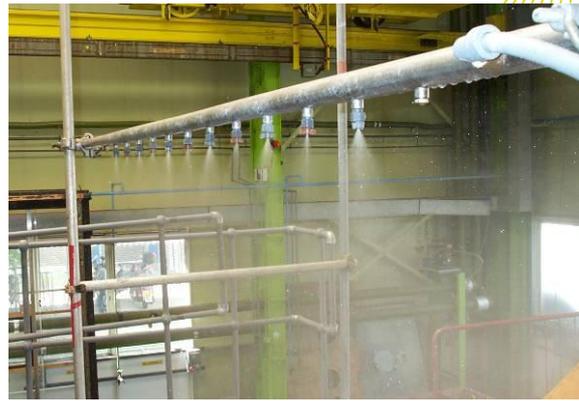
Figure C4 Top spray bar

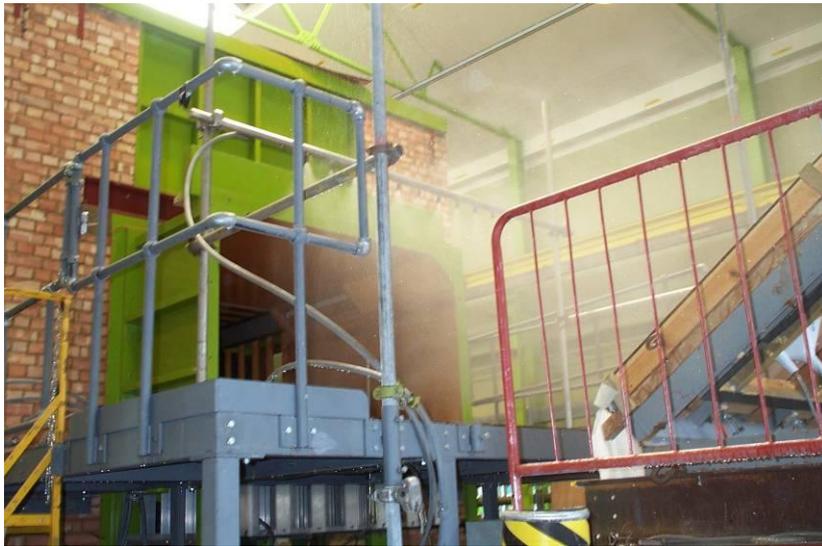
Figure C5 View of the test rig at the end of the tunnel

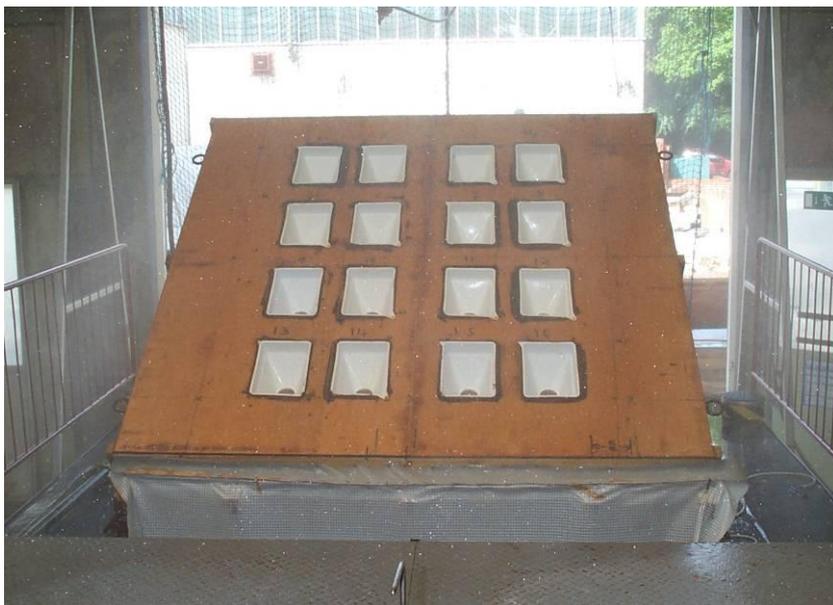
Figure C6 View of the 16 rainfall collection buckets on the test rig
