# BRE Test Report

## Rain Penetration Tests on Manthorpe Single Pantile Vent

Prepared for: Ben Hales  
Date: 18<sup>th</sup> April 2016  
Report Number: P104059-1000 Version 2

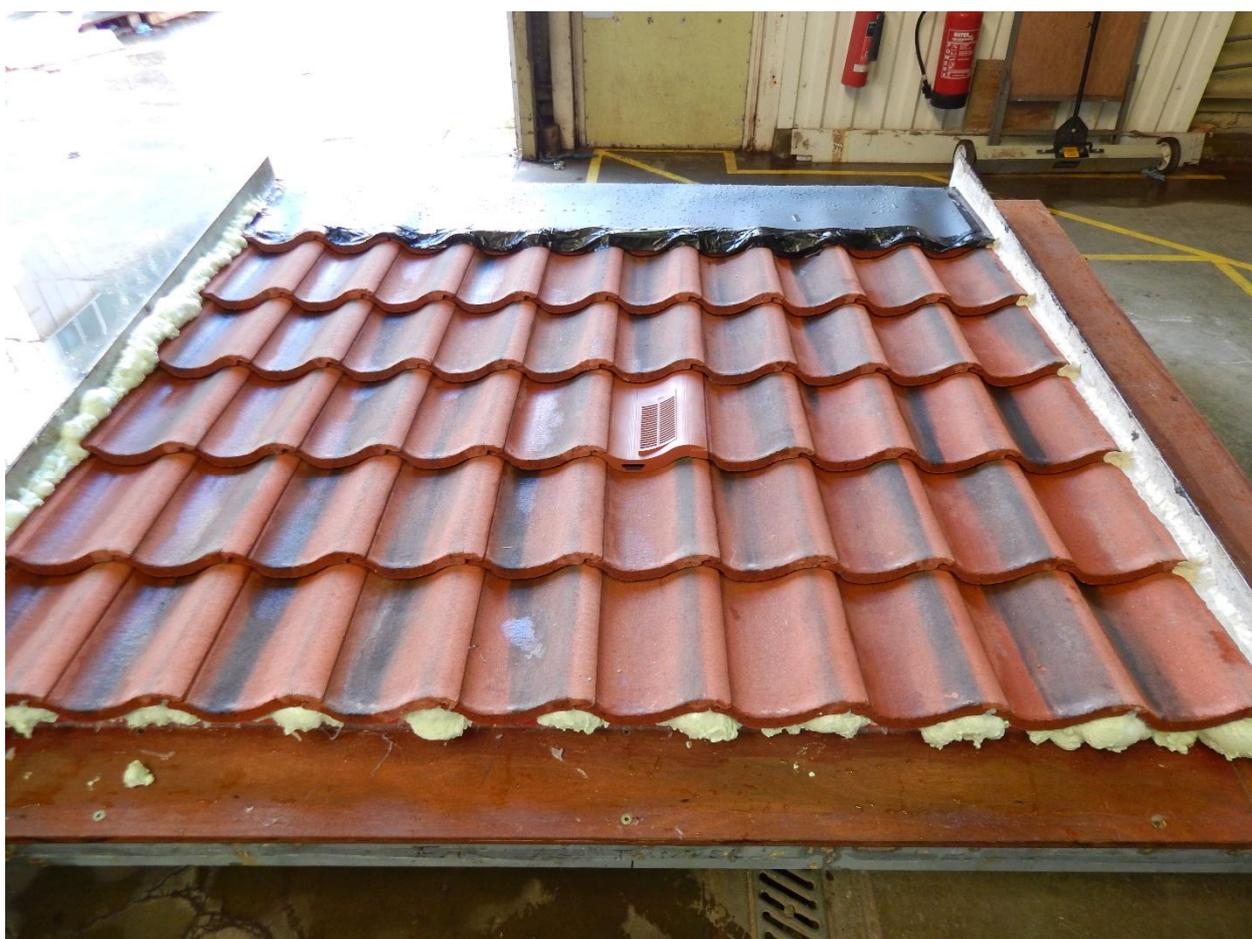
The vent and tiles were installed on the BRE test rig by Manthorpe employees. For these tests Redland Fenland concrete tiles were used. Figure 1 shows the vent installed in the rig.

Figure 1 Single Pan Tile Vent installed with Redland Fenland tiles

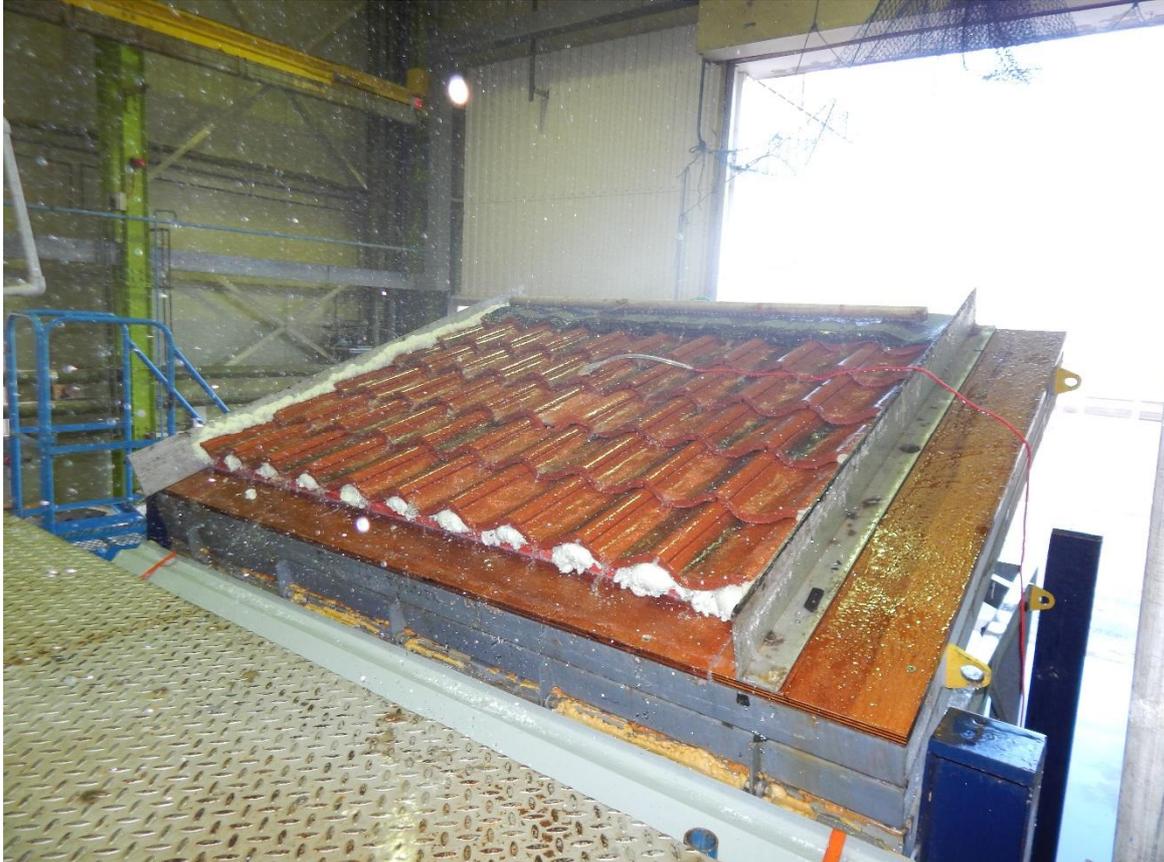
The performance of the roof vent was investigated using a purpose-built monopitch test roof of nominal size 2m x 2m. On the underside of the test roof, and central to it, a 1.8m wide x 1.6m long shallow Perspex box (open area 2.88m<sup>2</sup>) was mounted. It was this box that allowed the pressure underneath the tiles to be controlled. This test rig fully complies with the requirements laid down in FprEN 15601:2006 and has been calibrated to give the required uniformity of wind speed and rain flow across the test specimens. Results of the calibration tests on the BRE test rig and details of the turbulence intensity in the flow are presented in Annex B. Figure 2 shows the roof vent and tiles under test.

Figure 2 Manthorpe Single Pan Tile Vent with Redland Fenland tiles under test

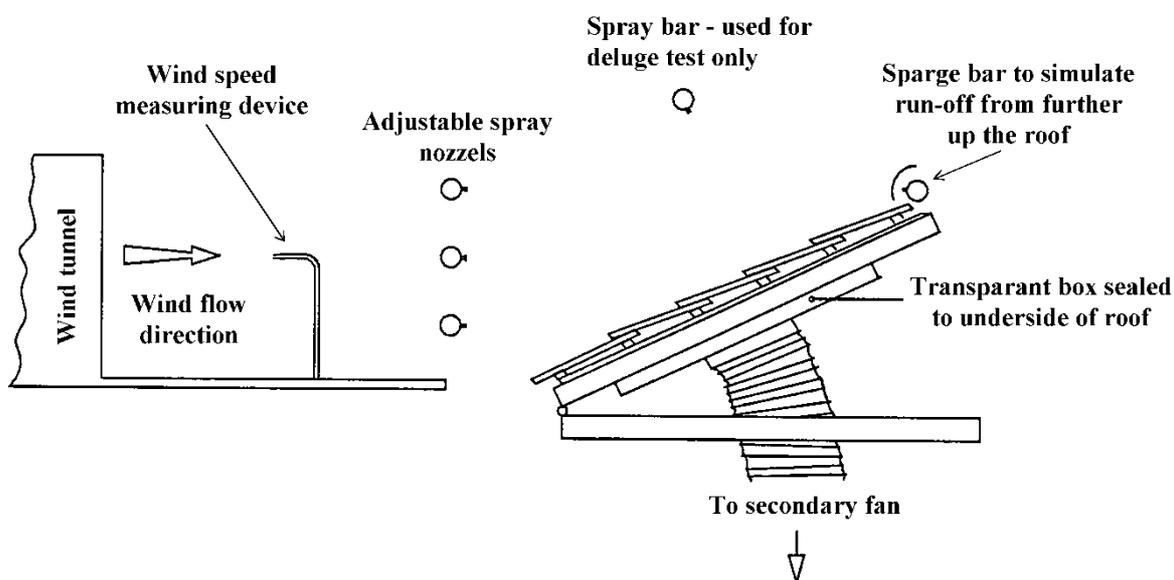
Figure 3 Schematic view of the BRE Rain Penetration Test Rig

The test procedures complied with those set out in FprEN 15601. The tests were carried out with the test roof mounted at the exit of BRE's No.3 Boundary Layer Wind Tunnel so that the wind flow was directed perpendicular to the eaves. Two horizontal spray bars were mounted at the exit from the tunnel, so that water could be sprayed into, and mixed evenly with the air stream. A schematic diagram of the test arrangement is shown in Figure 3. The test conditions represent the worst case wind and rain combination likely to occur in Northern Europe during any 50-year period.

A spray nozzle was mounted above the roof so that water could be sprayed down onto the roof to provide deluge rain. The wind tunnel was not running during deluge rain testing.

To simulate a typical 7 metre rafter length, a sparge bar was mounted across the top edge of the roof. The sparge bar was used to provide the quantity of runoff water that could be expected from a further 5 metre run of roof up to the ridge.

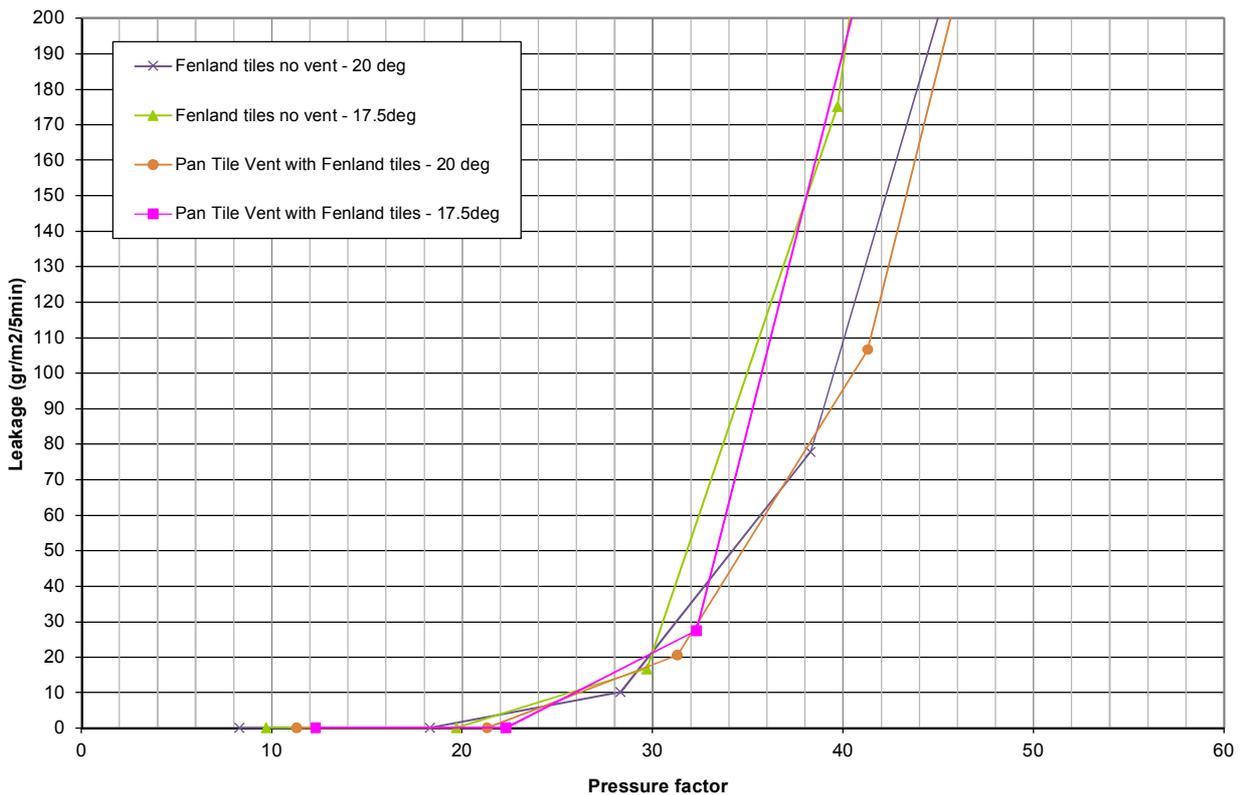
Figure 4 shows the pressure-leakage curves for the Manthorpe Pan Tile Vent.

It can be seen from Table 1 and Figure 4 that there is no significant difference in performance for the Manthorpe Pan Tile Vent installed with Fenland tiles and for the Fenland tiles on their own without the vent.

Figure 4 Pressure factor v leakage curves for the Fenland tiles and Manthorpe Pan Tile Vent

At a roof pitch of 17.5° the pressure factors are 26Pa and 26Pa with and without the Pan Tile Vent. At a roof pitch of 20° the pressure factors are 28Pa and 26Pa with and without the Pan Tile Vent.

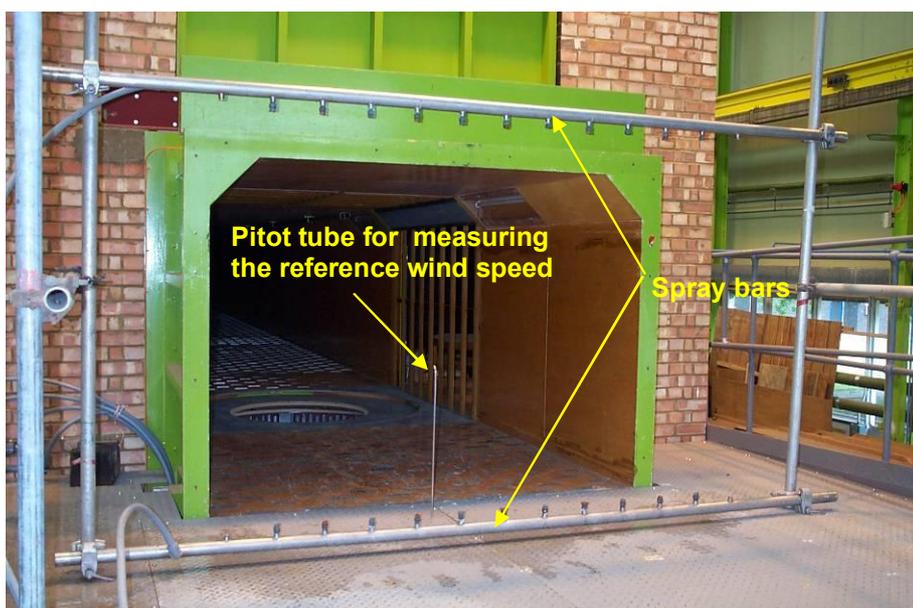
Figure B1 The end of the BRE wind tunnel

FprEN 15601 has specific calibration requirements for the test facility to ensure that the distribution and magnitude of the wind speed, driving rain and runoff water are all within required limits. The requirement for the wind speed generation is a fan system capable of generating wind blowing parallel to the rafters of the test specimen with a spatial variation of the wind speed over the specimen of not more than 10 %. This is achieved by measuring the wind speed at not less than 9 positions uniformly distributed at a height of  $200 \pm 10$  mm over a flat boarded area which replaces the test specimen, at the relevant roof pitch. The calibration wind speed shall be  $10 \pm 0.5$  m/s at the centre of the test specimen. Figure B1 shows the end of the BRE wind tunnel and Figure B2 shows the wind speed calibration of the BRE test rig using ultrasonic anemometers.

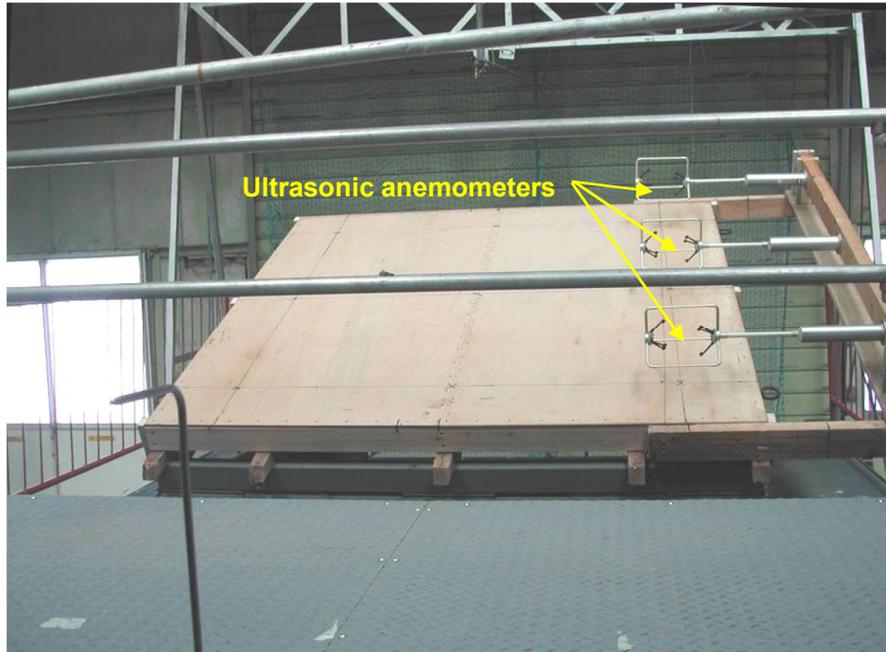
Figure B2 Calibration of the wind speed over the test specimen area

Table B1 shows the calibration measurements. The maximum turbulence intensity across the specimen is 5.57% and occurs at location 5 in the centre of the specimen. In all cases the turbulence intensity is within the limit of 10% allowed by the draft standard.

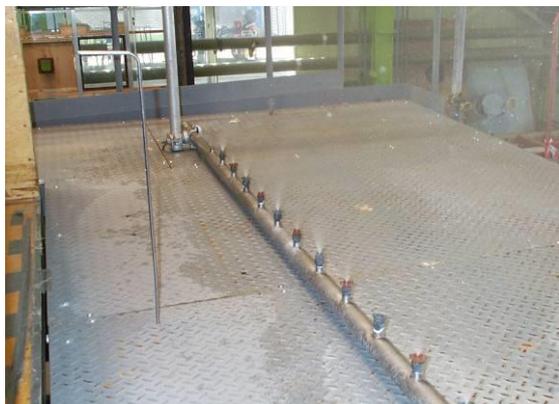
Figure B3 Bottom spray bar

Figures B3 to B6 show the calibration of the driving rain in the BRE test rig. The results of the calibrations for Sub-Tests A, B and C for the Northern European Coastal climate are shown in Table B2. From Table B2 it can be seen that the degree of variability in Sub-Tests A, B and C is close to but just within the allowable limit of  $\pm 35\%$ .

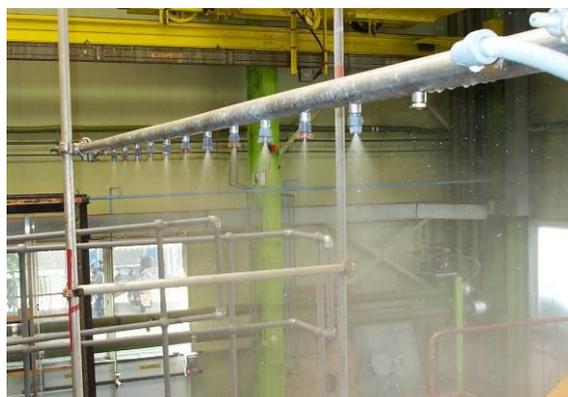
Figure B4 Top spray bar

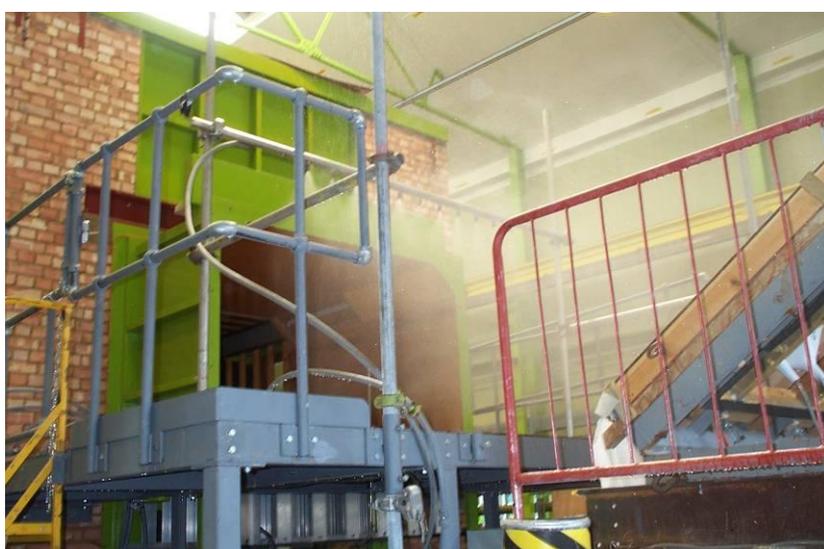
Figure B5 View of the test rig at the end of the tunnel

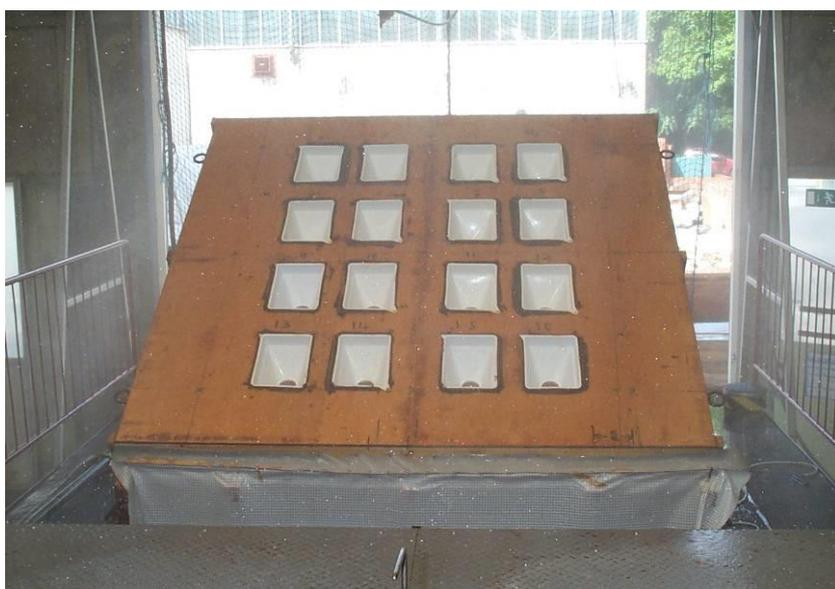
Figure B6 View of the 16 rainfall collection buckets on the test rig
