The Fire Resistance Performance Of Two Specimens Of Vertically Mounted Cavity Barriers And Two Specimens Of Horizontally Mounted Cavity Barriers, When Tested Generally In Accordance With EN 1366-4: 2006 +A1:2010

413654

**Manthorpe Building
Products Ltd**
Manthorpe House
Britain Drive
Ripley
Derbyshire
DE5 3ND

8th July 2019

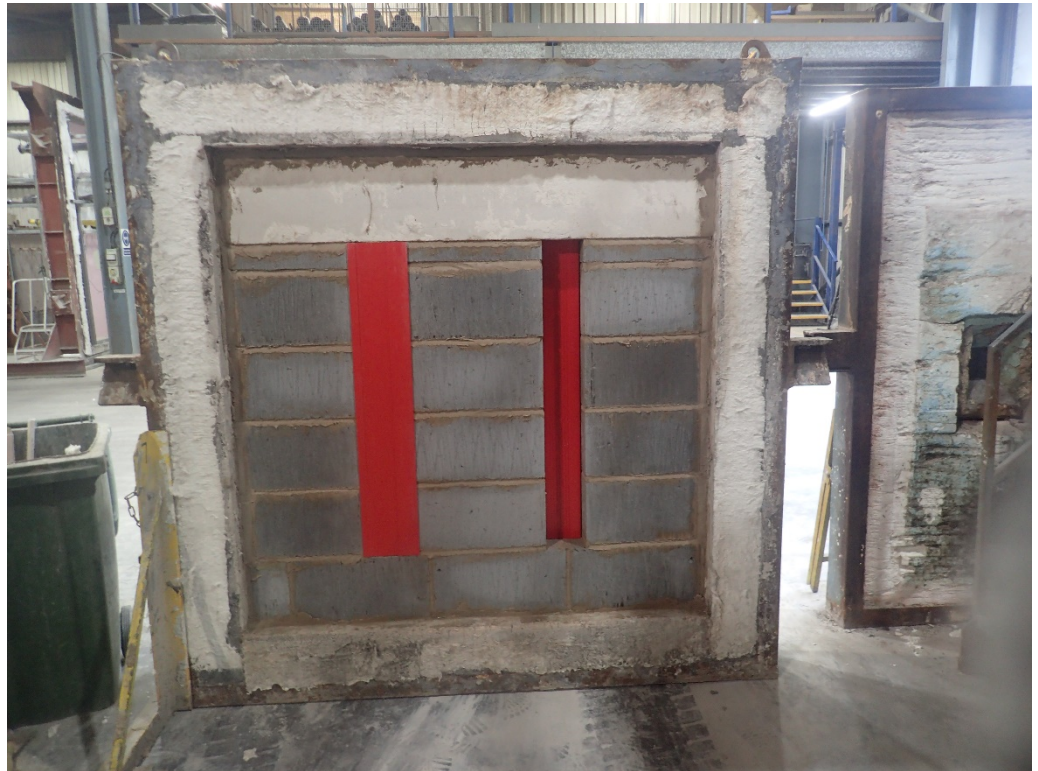
The exposed face of the wall construction prior to testing

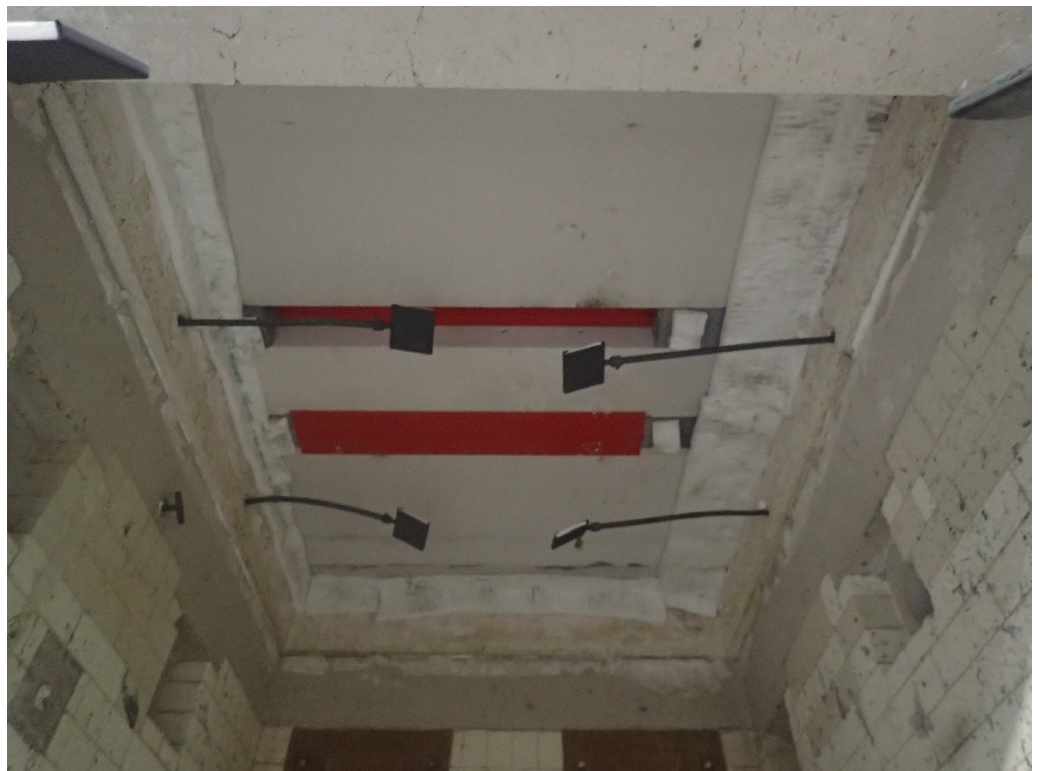
The exposed face of the floor construction prior to testing

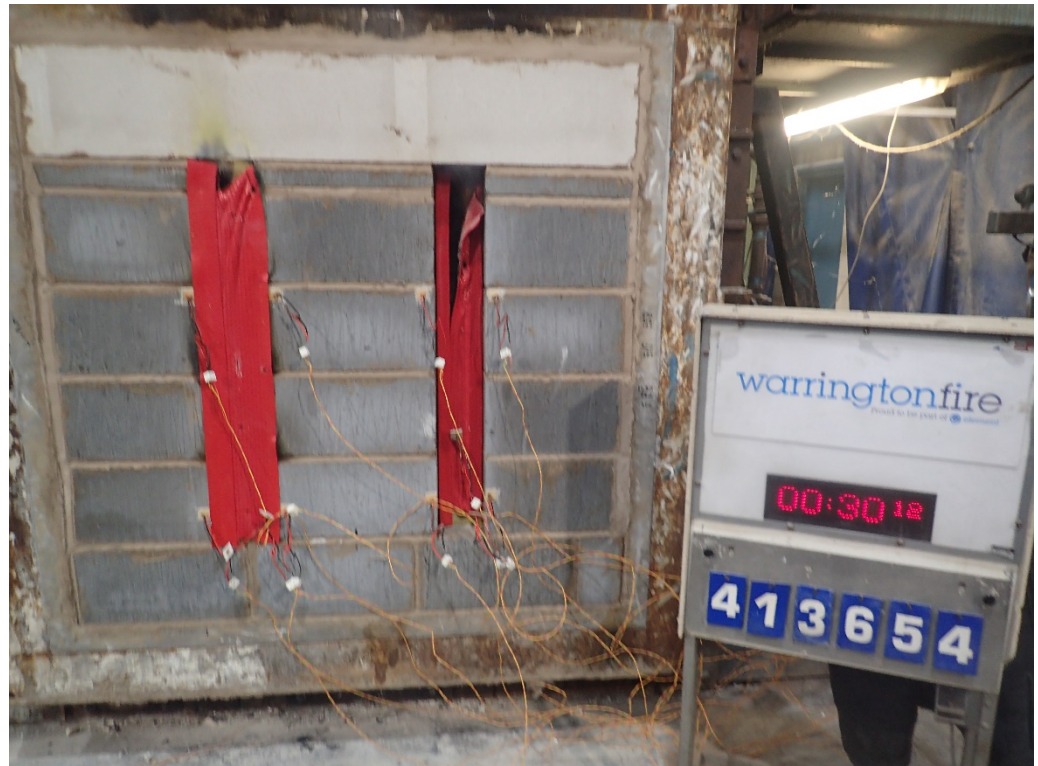
The unexposed
face of the wall
construction after
a test duration of
30 minutes

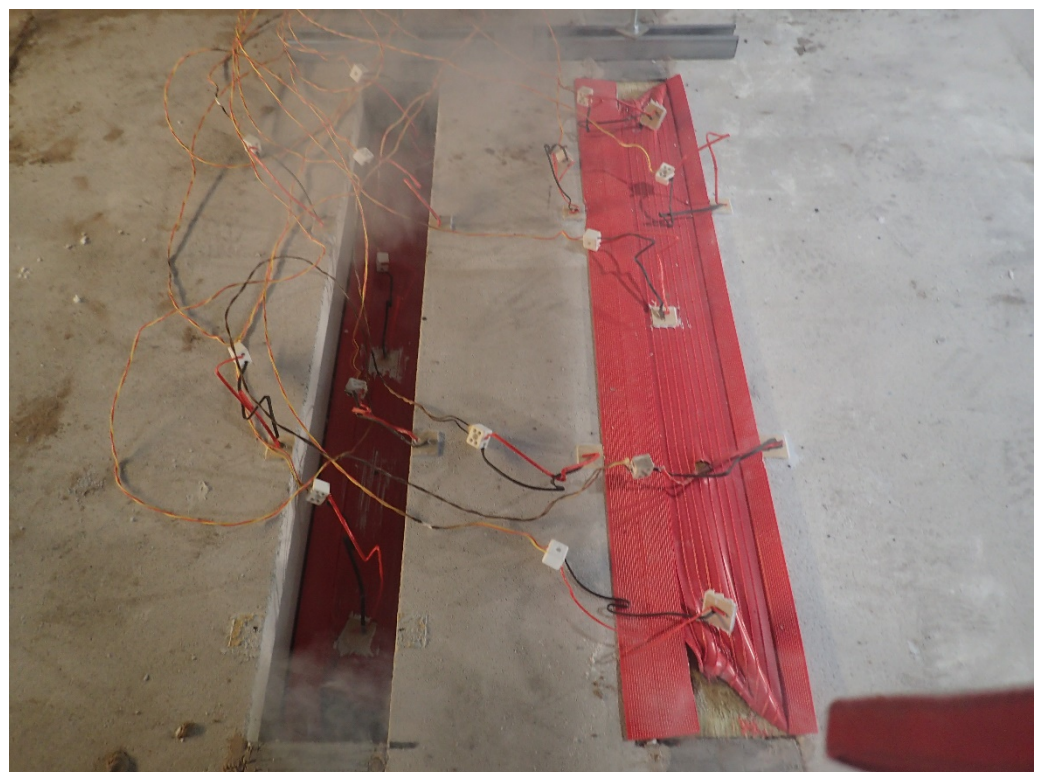
The unexposed
face of the floor
construction after
a test duration of
30 minutes

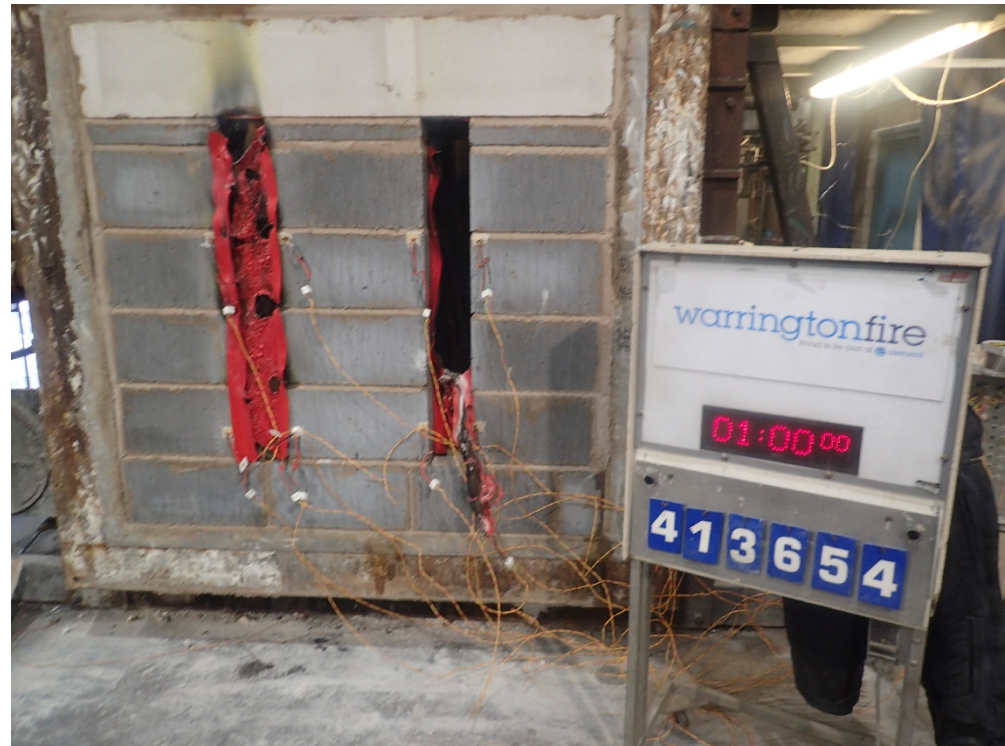
The unexposed face of the wall construction after a test duration of 60 minutes

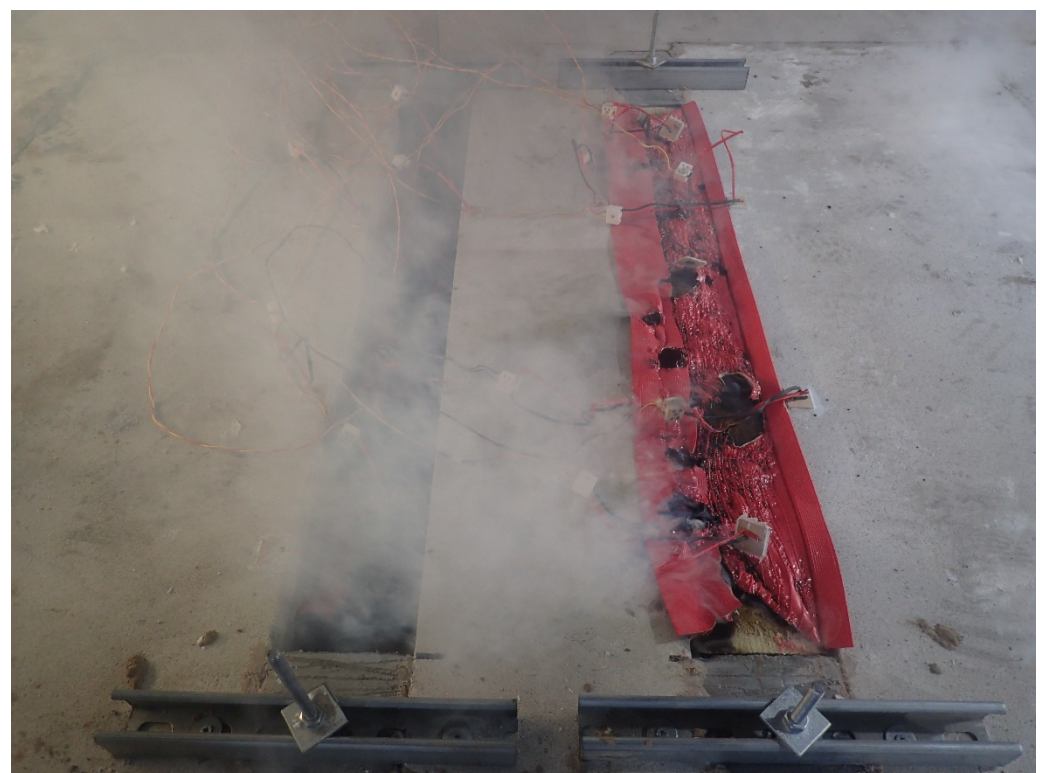
The unexposed face of the floor construction after a test duration of 60 minutes

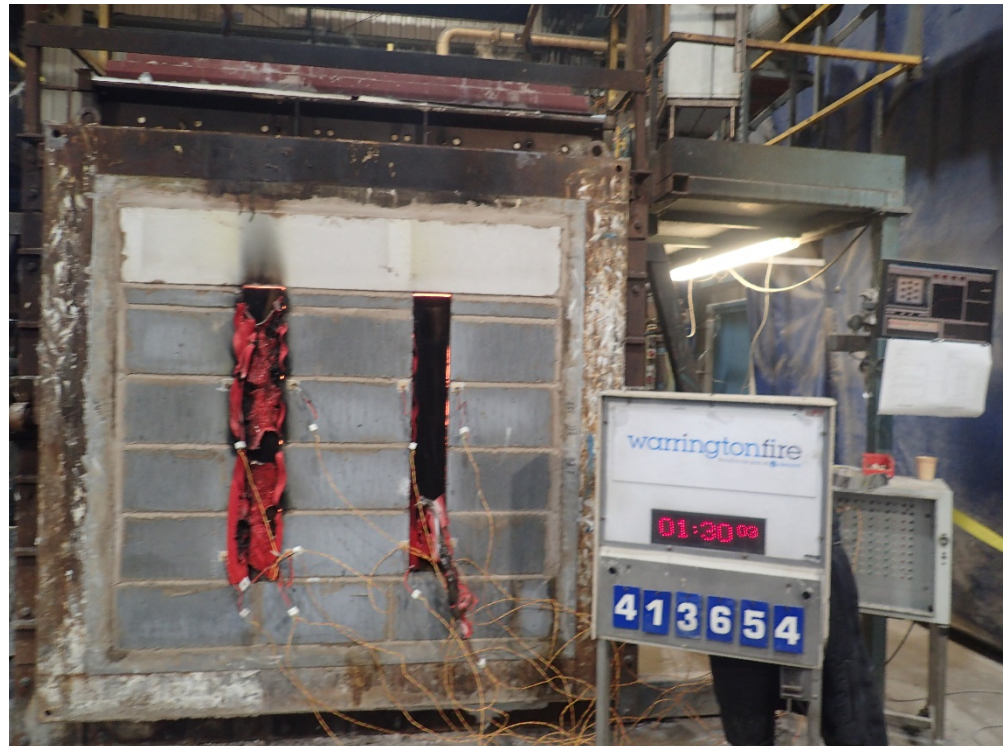
The unexposed face of the wall construction after a test duration of 90 minutes

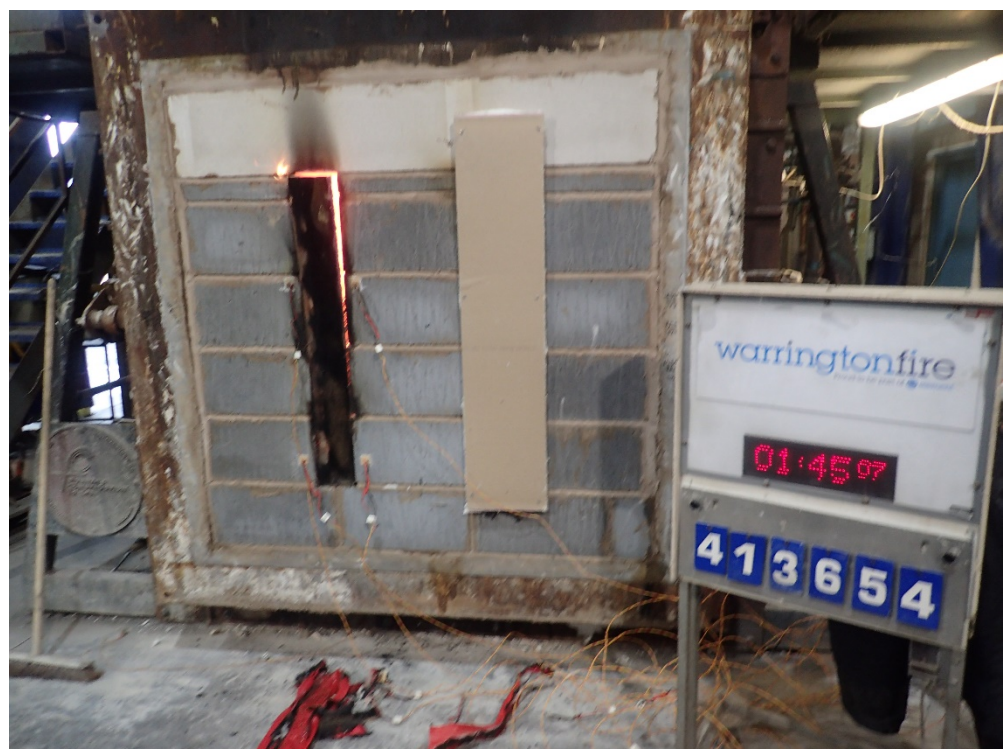
The unexposed face of the wall construction after a test duration of 105 minutes

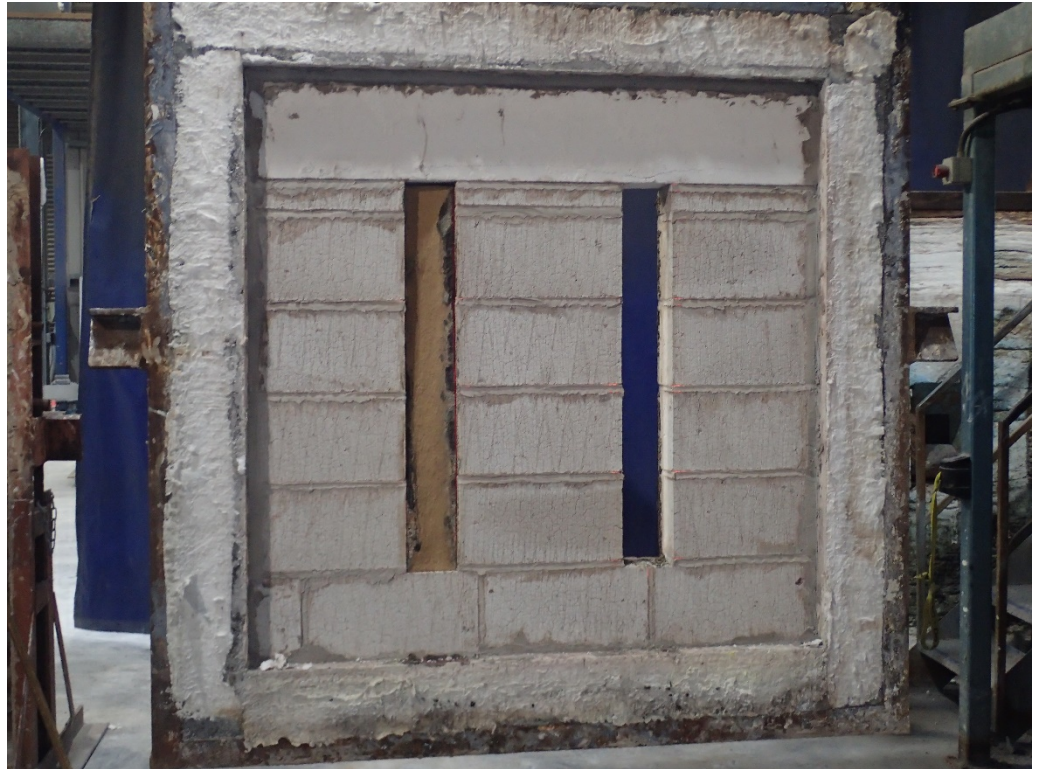
The exposed face of the wall construction immediately after the test

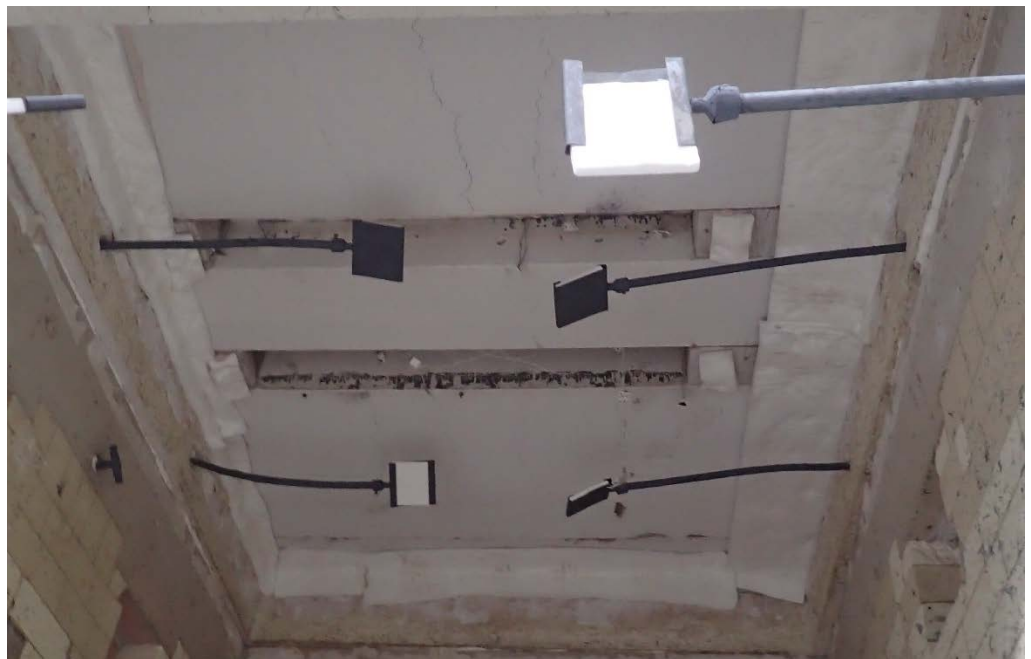
The exposed face of the floor construction immediately after the test
